PHASE I ENVIRONMENTAL SITE ASSESSMENT

**ALLENTOWN ARENA SITE
WEST HAMILTON TO WEST LINDEN STREETS
NORTH 6TH TO NORTH 8TH STREETS**

ALLENTOWN, LEHIGH COUNTY, PENNSYLVANIA

Benesch Project No. 00060089.00 task 00001

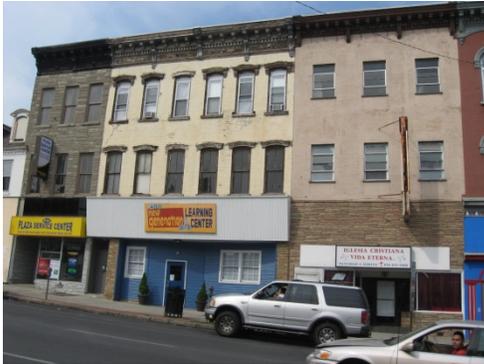
42 North 7th Street

- Accompanied by Owner Marian Estevez and Building Manager Abraham Prosper.
- Current use daycare and apartments, 1st floor and upper level, with basement.
- No ASTs, USTs, hazardous materials use/storage/spills.
- No obvious PACMs (potential asbestos containing materials e.g. thermal system insulation [known as TSI] or trowled on surfacing materials). Some 9"x9" vinyl floor tile is present at this location.
- Some water damage evident in basement.
- City water/sewer.
- Old freight elevator is present, not usable.

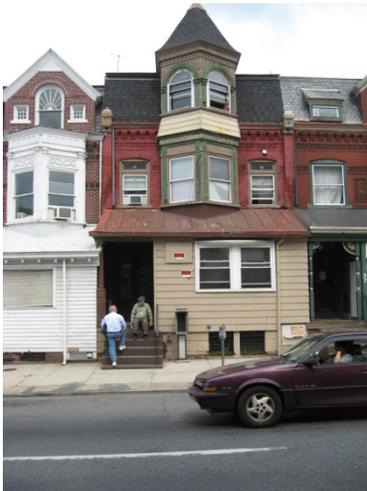
39 North 8th Street

- Owner Saeed Moghal.
- Current use apartments, 1st floor and upper levels, with basement.
- No ASTs, USTs, hazardous materials use/storage/spills.
- No obvious PACMs. Some 9"x9" vinyl floor tile is present at this location.
- City water/sewer.

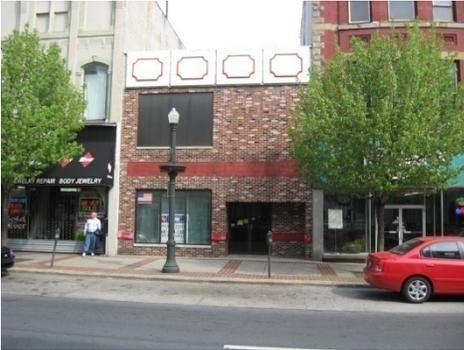
709 West Hamilton Street

- Former restaurant 1st floor and upper level, with basement.
- No ASTs, USTs, hazardous materials use/storage/spills.
- No obvious PACMs.
- Significant water damage evident with poor roof.
- Assumed city water/sewer.

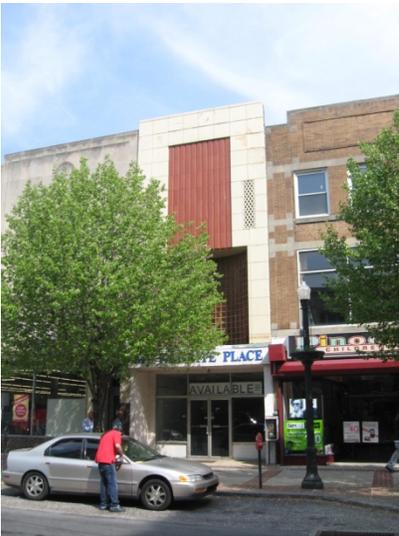
- Former retail 1st floor, upper two levels former residential and commercial, with basement.
- No ASTs, USTs, hazardous materials use/storage/spills.
- No obvious PACMs except fibrous roofing materials, extensive 9"x9" vinyl floor tile.
- Access on upper floors of 723 West Hamilton Street apparently extends to the 725 and 727 structures located west of 723 Hamilton.
- Significant water damage evident with roof in poor condition.
- Assumed city water/sewer.
- Probable localized fire occurred on 2nd floor residential units.
